**BIO SECURITY POINTS – CRITICAL ANALYSIS REPORT**

January 2017

## Bio Security Points – a Short Assessment Report

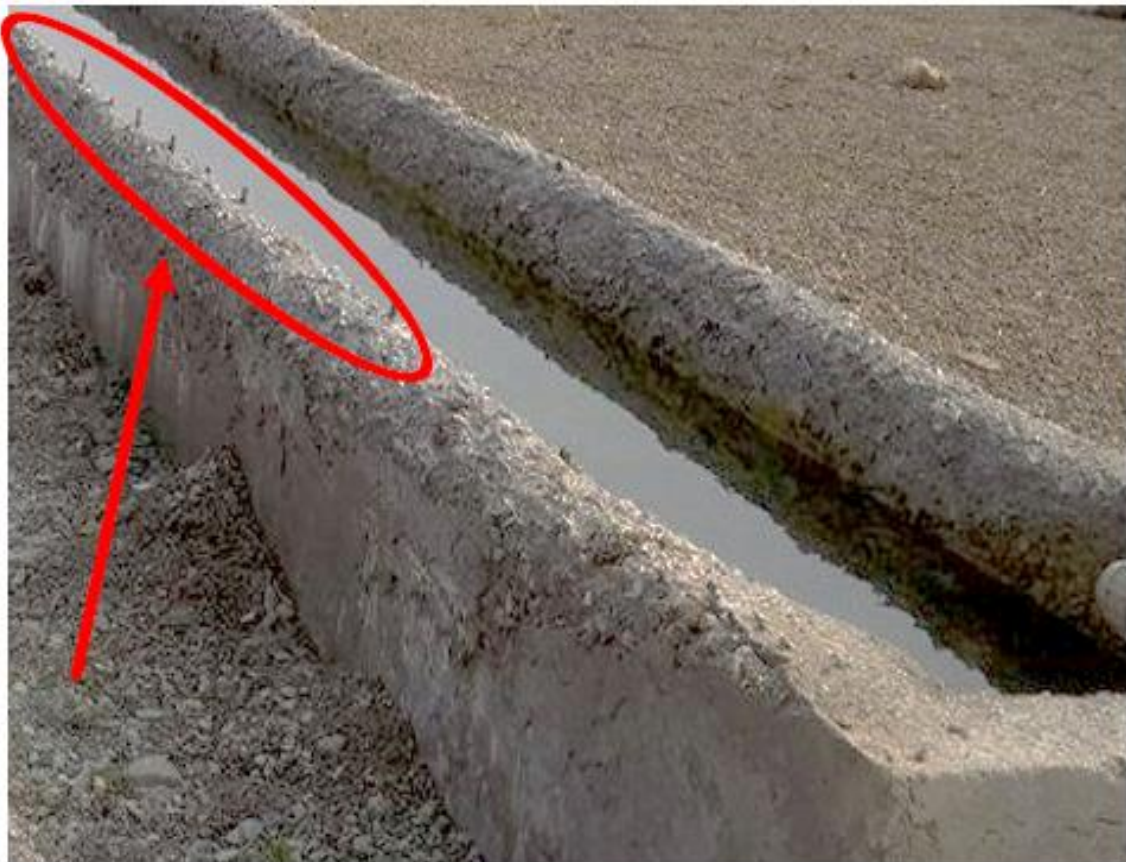
**Water Point at Marneuli BSP**

- **Water points:** one of the water points is damaged and is injurious to animal safety
- **Sheep dipping baths:** only one of the baths is functional, another one is jammed with waste. Local staff are unable to solve the issue

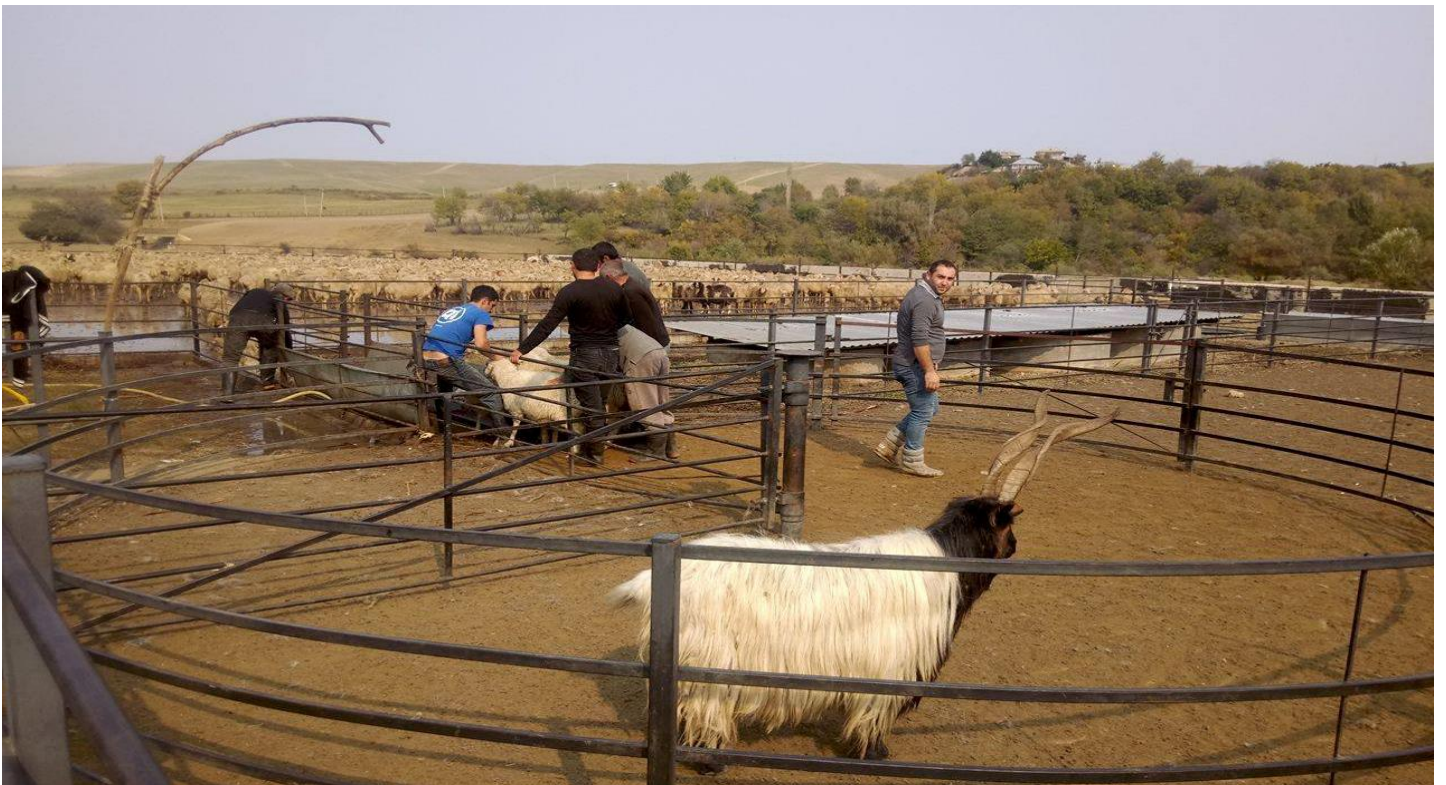
only one bath is used for dipping at Marneuli BSP

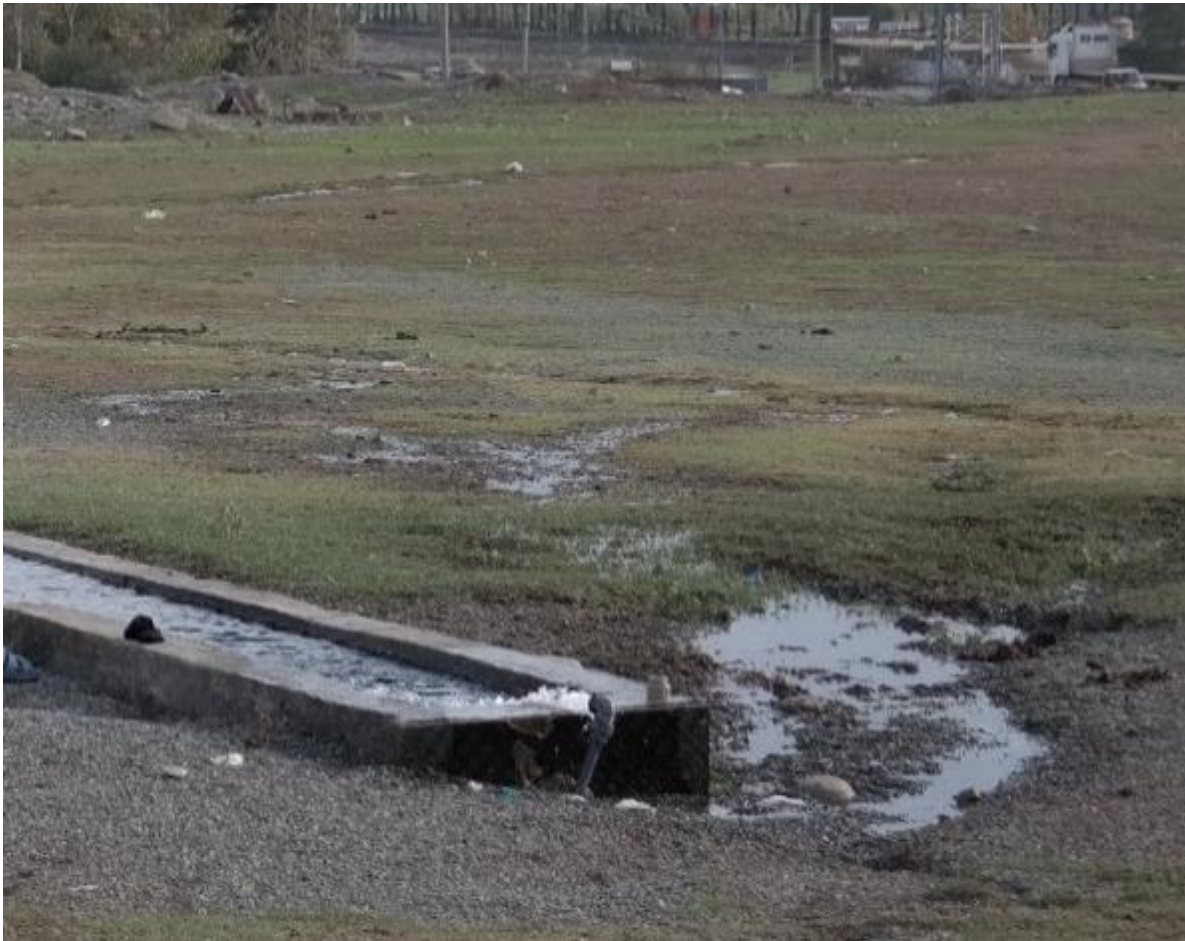
Water Point at Rustavi BSP

- Water tank on the point is damaged and not connected the water provision system. The facility is supplied with water directly through the tap, where sometimes water is interrupted. For this reason there are cases when BSP stops operation due to the absence of water supply
- The tap of the water point is broken and the water permanently flow down from it - *Solved by now*
- Spray nozzles needs to be replaced and additional ones added at cattle shower
- Circular pen and cattle entry door need repairing
- Toilet is not functioning, as it is not connected to the existing water provision system. A few meters of pipe and minimum expense is enough to solve the issue.
- Provision of electivity would improve working conditions of the BSP staff members

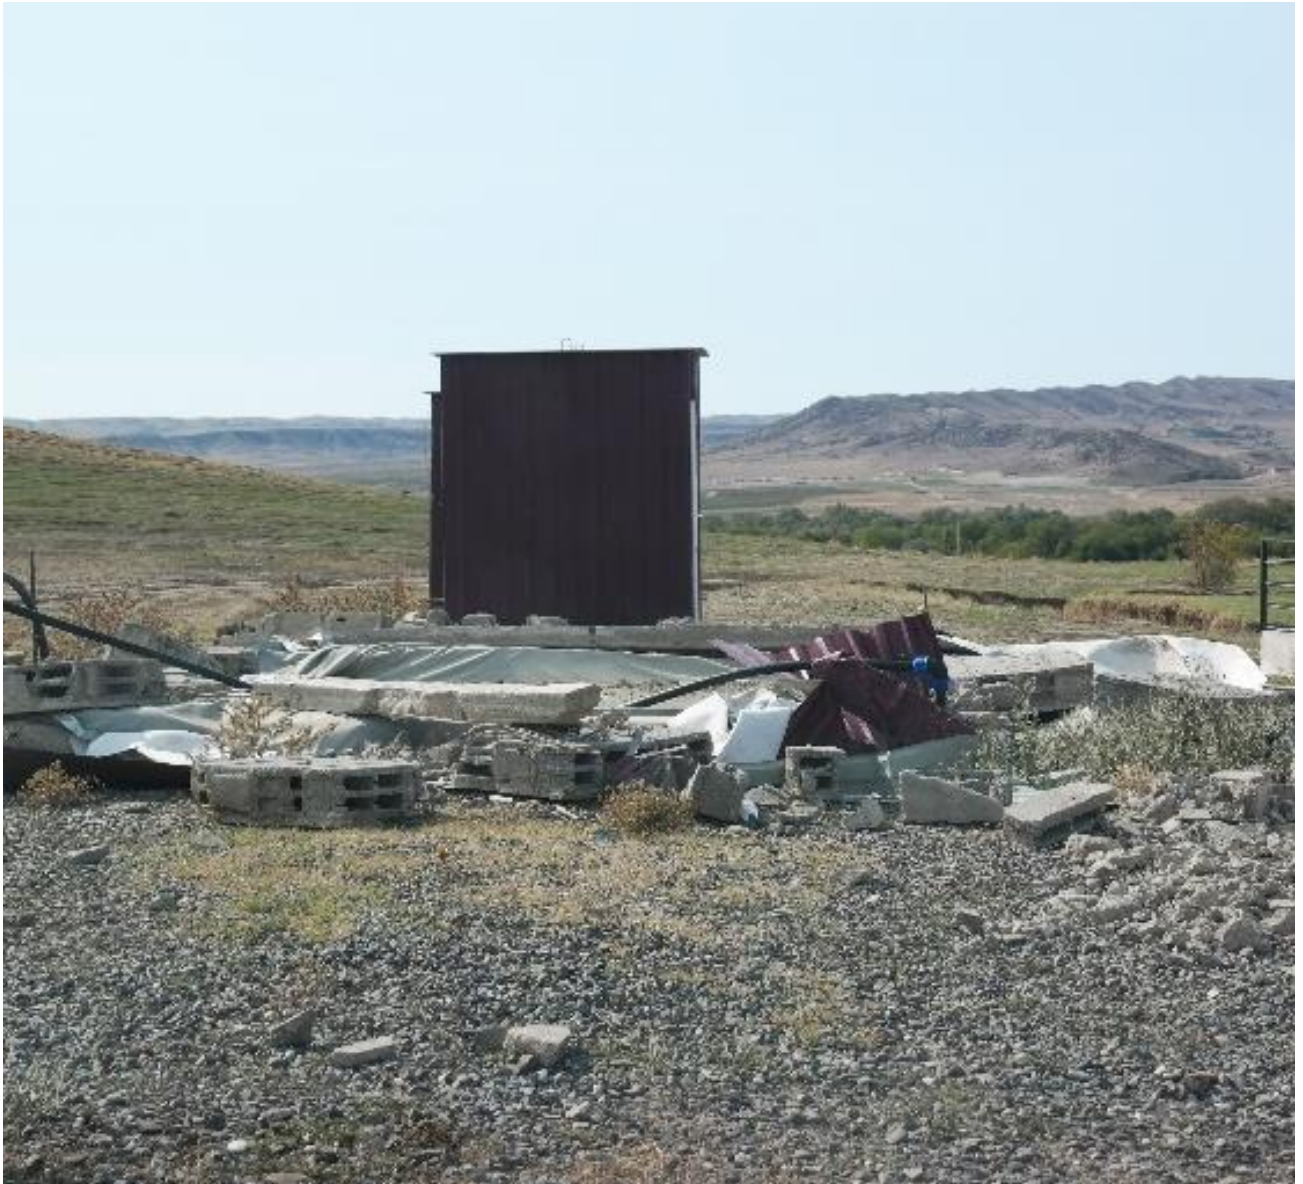
- The BSP Water supply system is malfunctioning, the pump is not working properly - *Solved by now*
- The water tank that had been built at the point is damaged due to the low quality of provided construction works. The contracted company that is responsible to re-build the tank in warranty period is not fulfilling contract terms.
- Water points are also damaged also due to poor quality construction

Ruins of Water Tank at Signagi BSP

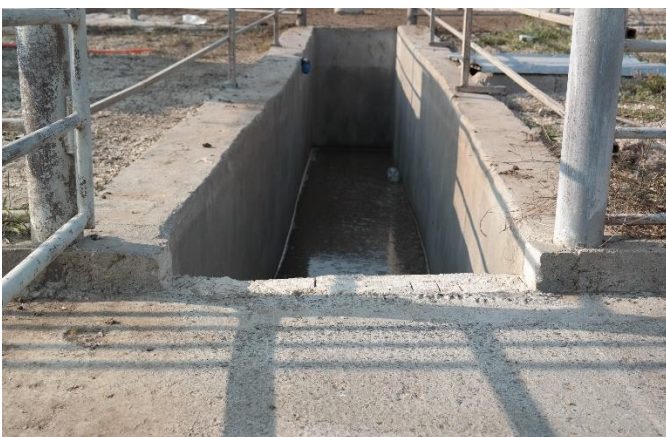
Sheep bath at Dedoplistskaro BSP

- The BSP were not fully prepared properly to start working: the point were not clean, the sheep dip bath was full of dirty water as well as the septic tanks
- The entry door of circular pen is narrow that will make hard to herding in sheep

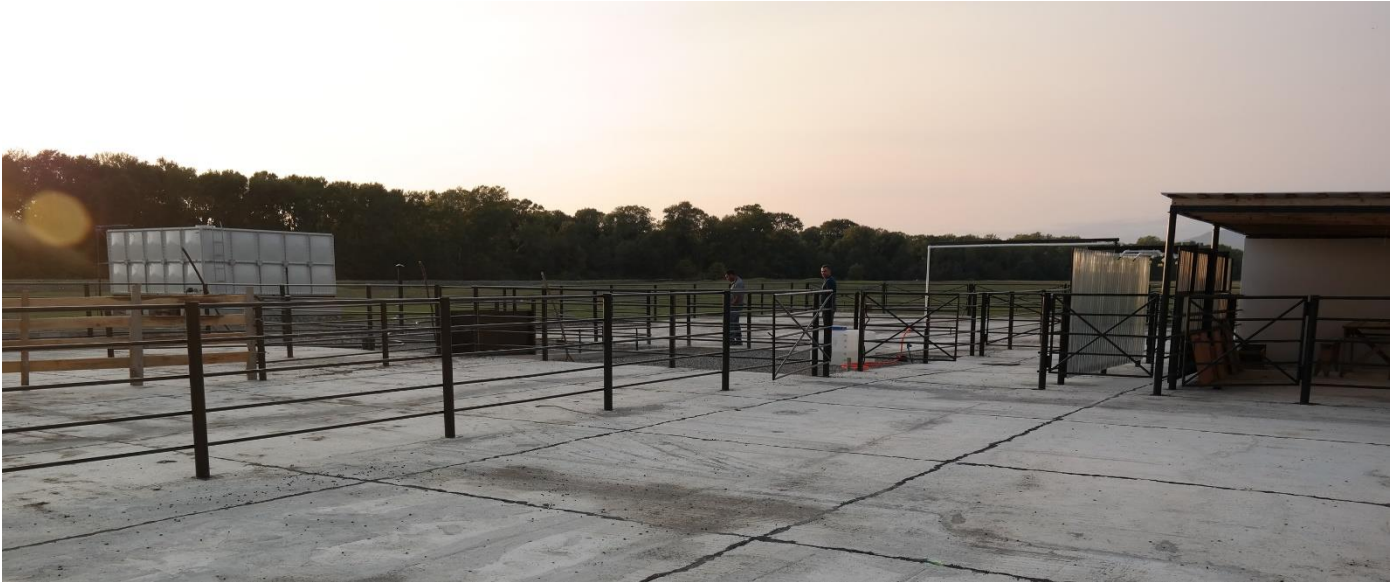
### Photos from Telavi BSP

Water point location is not good, better to be located separately not on the fence of the Bio Security Point
